**DRAFT REPORT
ROUND 10 DAM ASSESSMENT - MAY 18, 2011
PPL GENERATION, LLC.
BRUNNER ISLAND POWER STATION
ASH BASIN NO. 6 WITH POLISHING POND, EQUALIZATION POND AND
INCIDENTAL WASTE TREATMENT BASIN (IWTB)
YORK HAVEN, PENNSYLVANIA**

**GZA GeoEnvironmental, Inc.
One Edgewater Drive
Norwood, Ma 02062
GZA File No. 01.0170142.30**

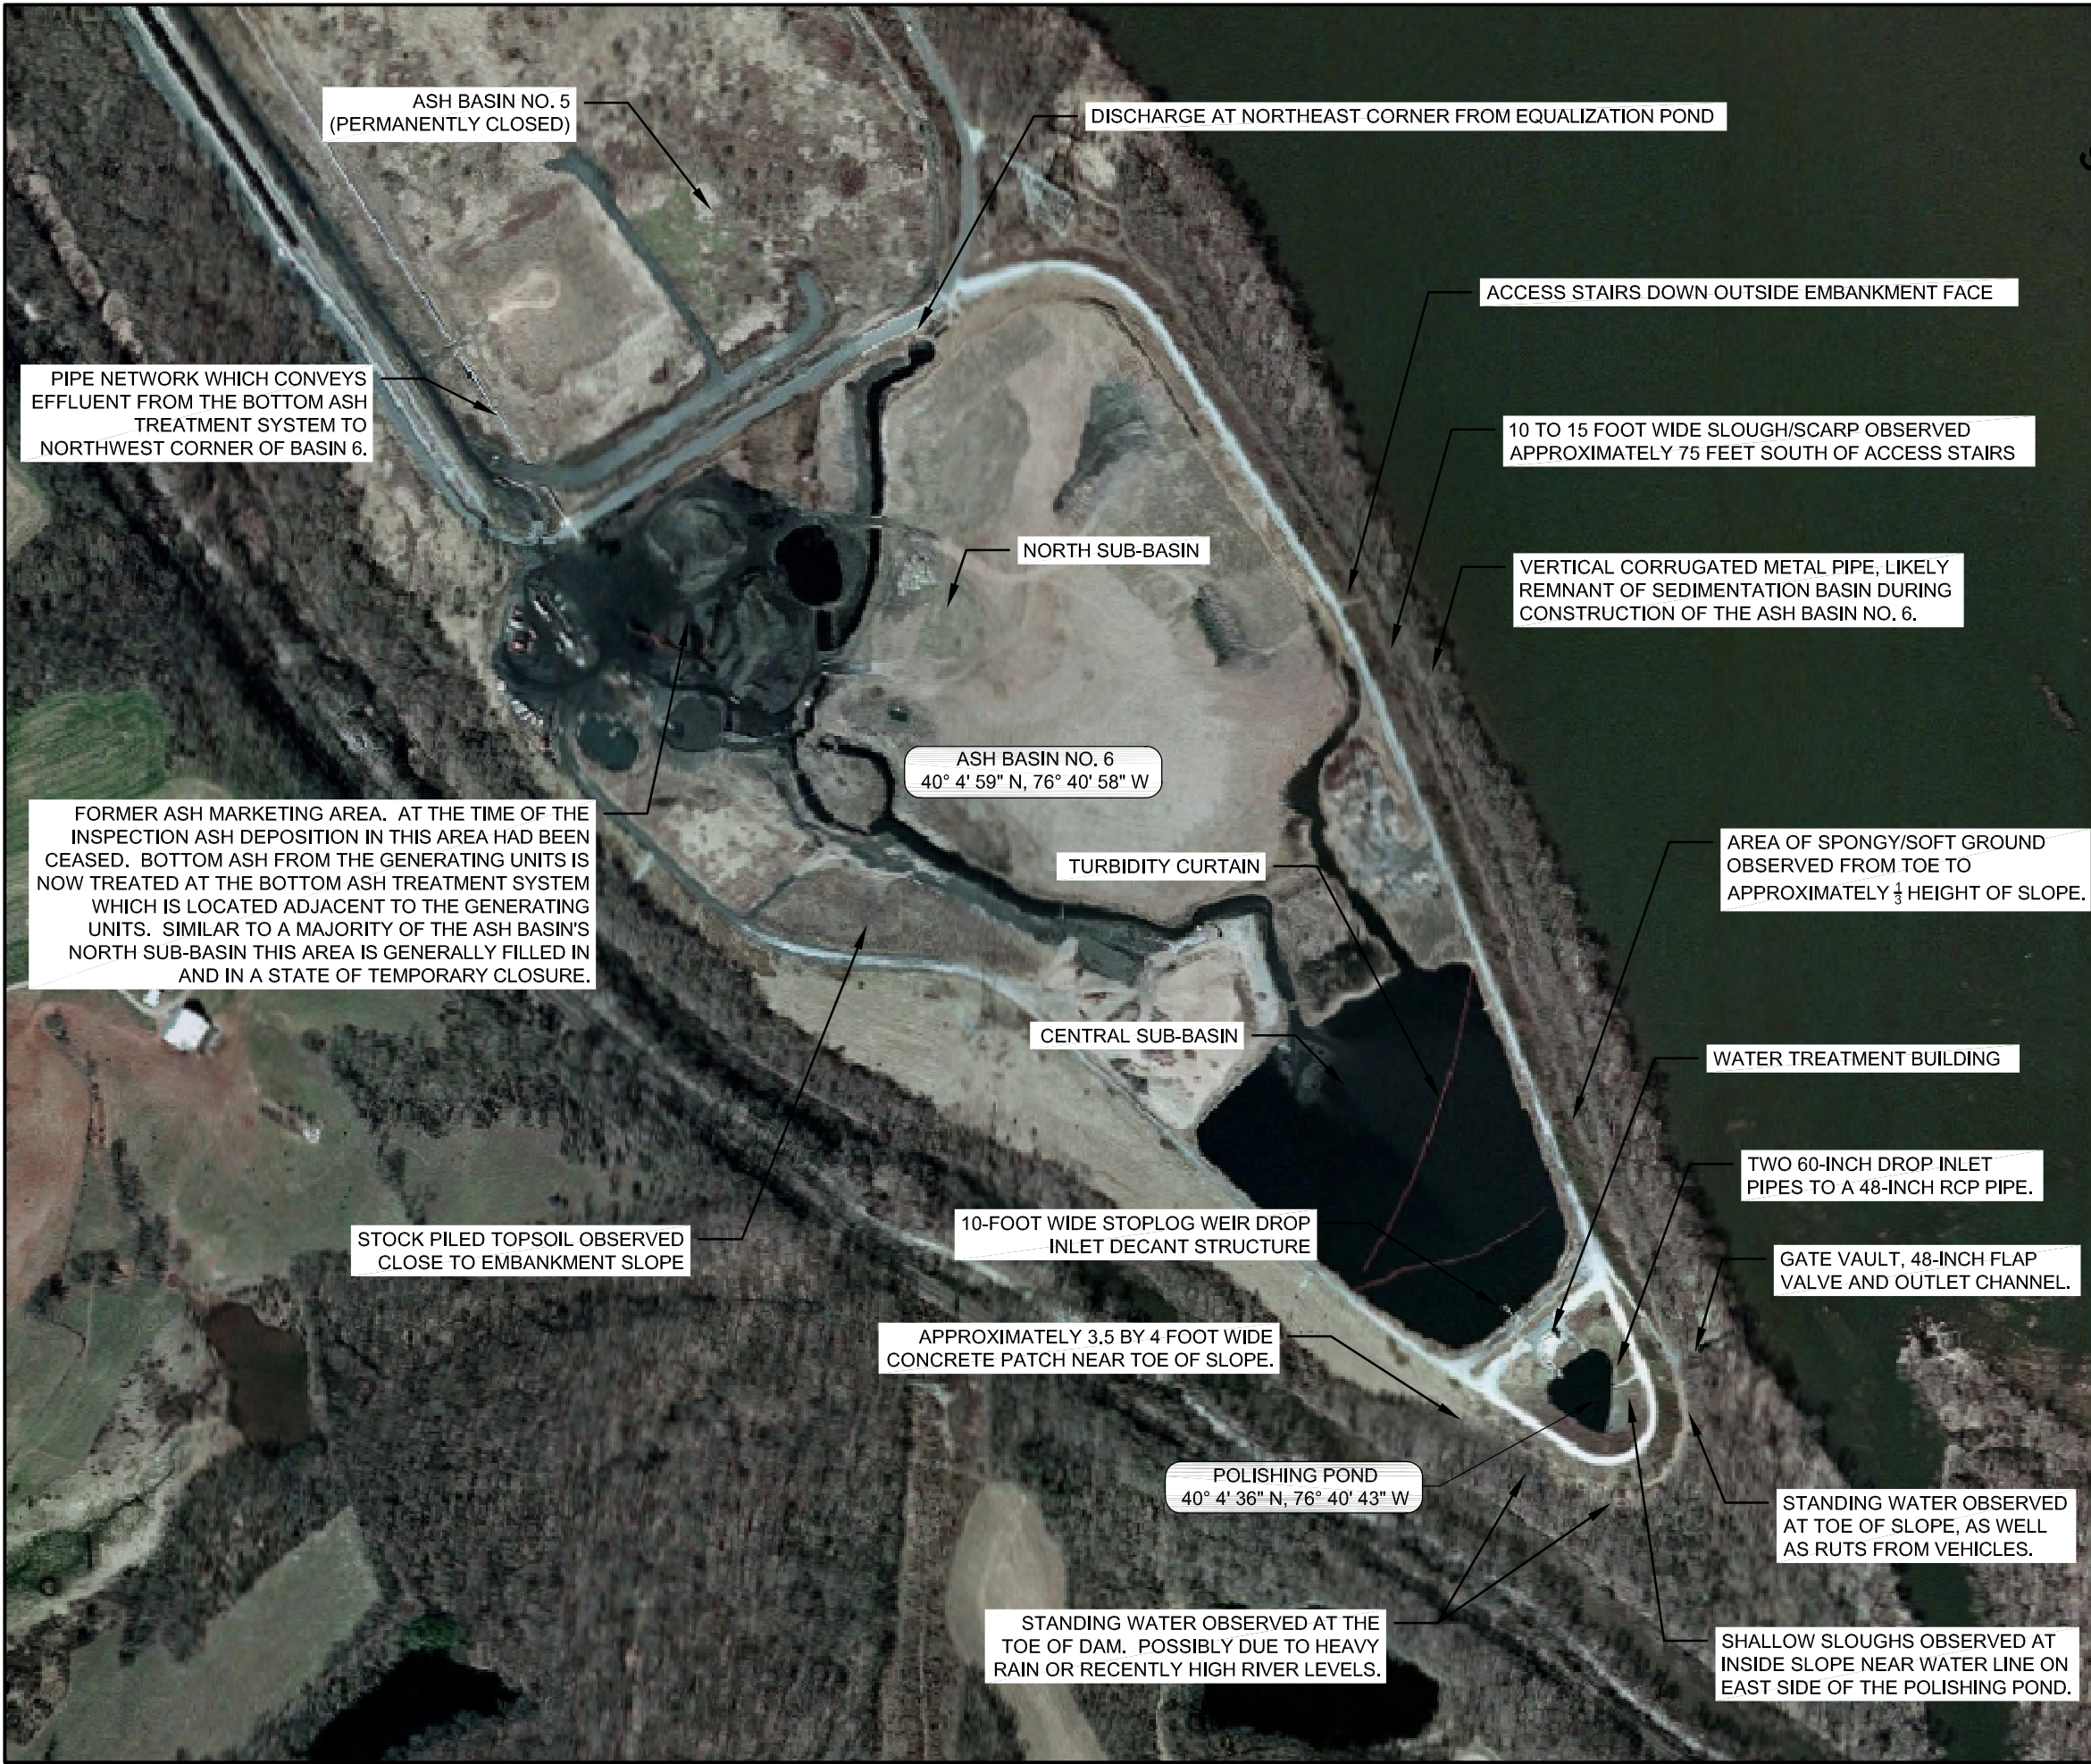
Based on the results of the visual inspection, discussions with PPL personnel, and a review of available design documentation, Ash Basin No. 6 was judged to be in **POOR** condition. The following deficiencies were noted at the CCW impoundment, Ash Basin No. 6:

1. Based on the results of a stability analysis by PPL's independent dam engineering consultant HDR Engineering, Inc., of Portland, Maine, insufficient factors of safety were calculated for the rapid drawdown condition. This is the primary reason for the impoundment's Poor Condition rating.

2. Overgrown vegetation, up to 36 inches high, at outside embankment slopes and portions of inside embankment slopes. Overgrown vegetation may obscure potential detrimental embankment conditions.

3. Ruts and depressions observed at portions of the embankment toe from vehicles.
4. Saturated portions of embankment and standing water observed at the toe of dam at various locations around the polishing pond and east embankment. Conditions possibly due to heavy rainfall over the prior week. According to PPL personnel waters of the Susquehanna River had recently receded from the areas surrounding the toe of the embankment, which may also have contributed to the standing water and saturated conditions.

5. Sloughing observed at inside slope of the Polishing Pond, especially near the water line at the east side. Sloughs and scarps observed generally less than 3 feet deep.

6. Erosion from surface water runoff observed at the inside face of the Polishing Pond near the north end.
7. Approximately 40 foot long section of spongy/soft soil observed the east embankment near the south side from the toe to approximately 1/3 the height of the embankment. Note this condition was also reported on previous inspection reports by HDR Engineering, Inc.

8. Minor depressions and erosion observed at the crest.
9. 10 to 15 foot wide slough/scarp at the east embankment approximately 75 feet south of the access stairway on the outside face.

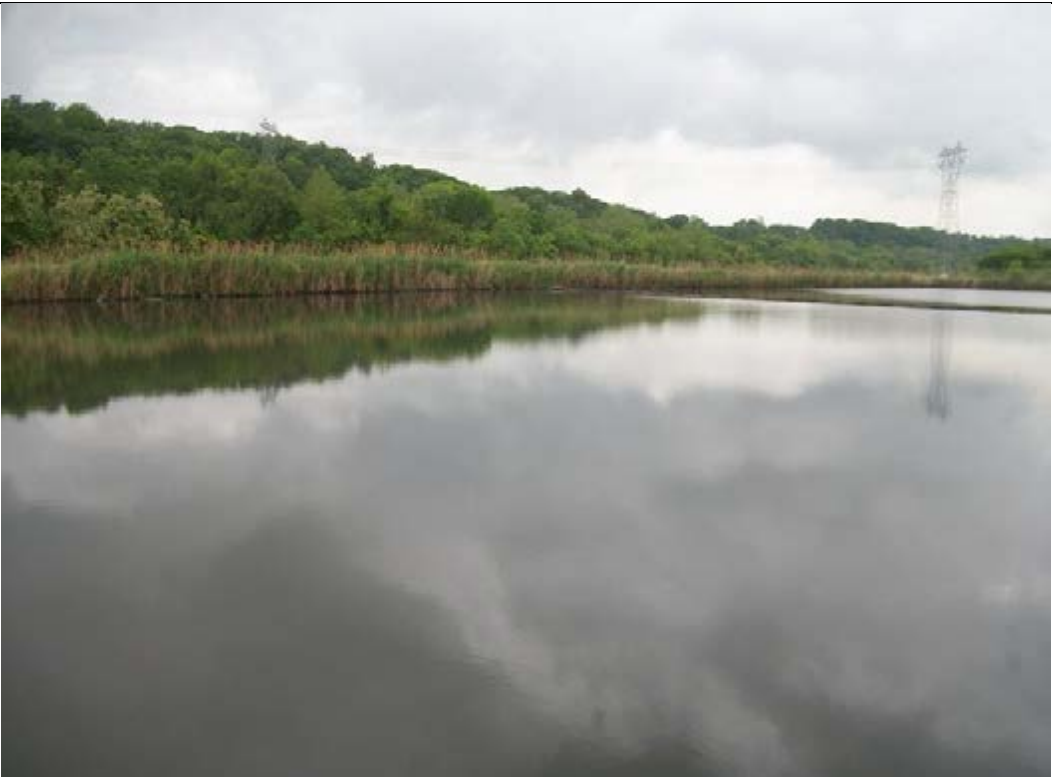
Direction Photo Taken: Westerly			
Description: Overview of west side of Ash Basin No. 6 as viewed from the decant intake structure. Note high vegetation/reeds along inside slope of basin.

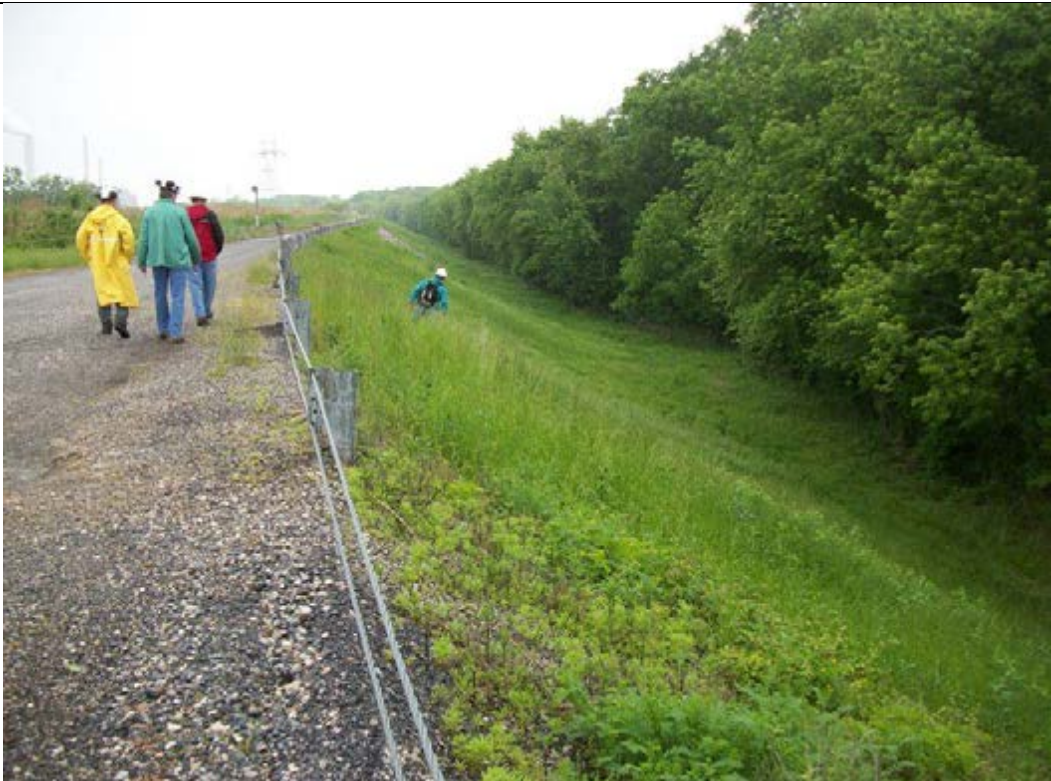
The East embankment generally appeared to be in fair condition. Grass and vegetation was overgrown at the outside slope and was approximately 12 to 36 inches in height (Photos 6 & 12). Standing water was observed at the toe, however heavy rains from the week prior to the inspection and recently high river levels from the Susquehanna may have contributed to the conditions at the toe (Photo 13). An approximately 40 foot wide spongy/soft area of ground was noted at the southern portion near the Polishing Pond to approximately 1/3 up the embankment, no movement was noted. A scarp was observed at the downstream toe approximately 75 feet south of the stairs from the crest (Photo 14).

Direction Photo Taken: Northerly			
Description: Outside slope of Ash Basin No. 6 east side embankment taken from the southeast corner of the basin.

1. Maintain grass cover on the downstream slope and approximately 15 feet beyond the toe area. USACE recommends vegetation be kept less than 12 inches in height on embankments. This may required mowing more frequently than bi-annually.
2. Fill ruts, depressions, and animal burrows and reseed if necessary.
3. Monitor and repair sloughing at the inside slope at the Polishing Pond and outside slope at the east embankment, or other locations sloughing is observed.
4. Exercise stoplogs and slide gates at least once annually.
5. Monitor spongy/soft ground observed at the east embankment.

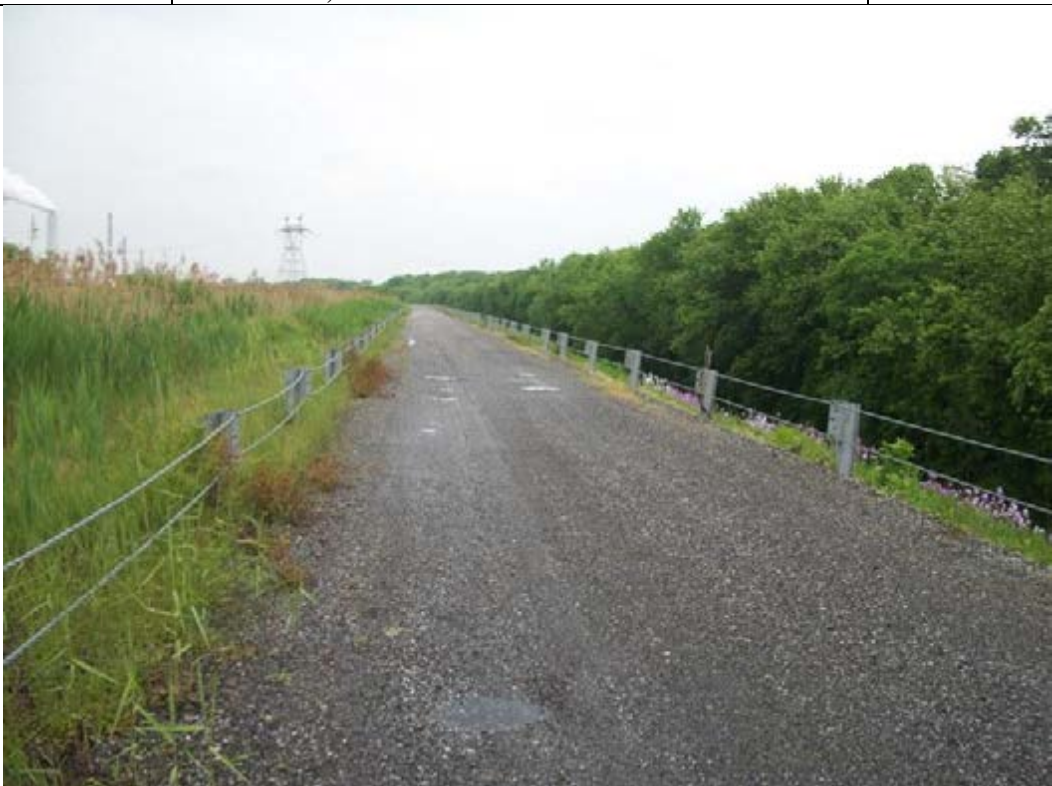
Client Name: U.S. Environmental Protection Agency		Site Location: PPL Brunner Island Station Ash Basin No. 6, York Haven, PA	Project No. 170142.30
Photo No. 7	Date: 5/18/2011

The crest of the west embankment consisted of a crushed stone travel way. Minor depressions and ruts were noted at various locations along the crest (Photo7).

Direction Photo Taken: Northerly			
Description: Crest of Ash Basin No. 6 east side embankment looking north.

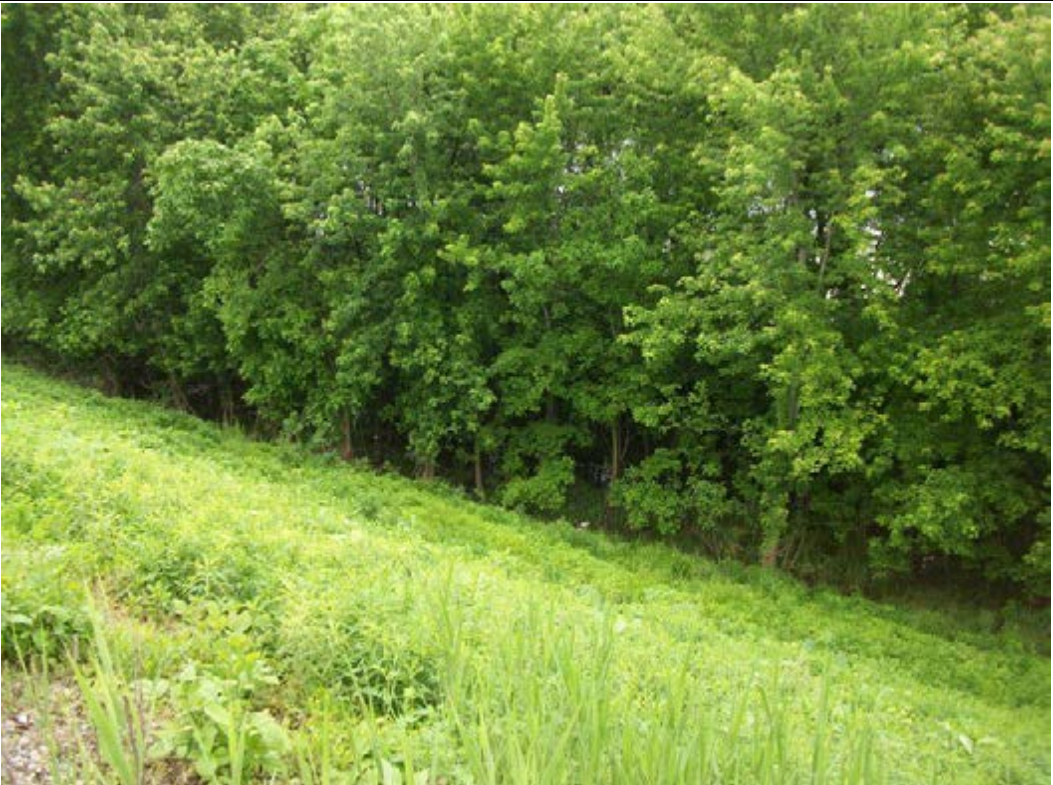
Direction Photo Taken: Northeasterly			
Description: Outside slope along east side embankment near southeastern end. Heavy tree/forest growth abuts toe of embankment along the majority of the east side. Note water through/beyond the trees is the Susquehanna River.

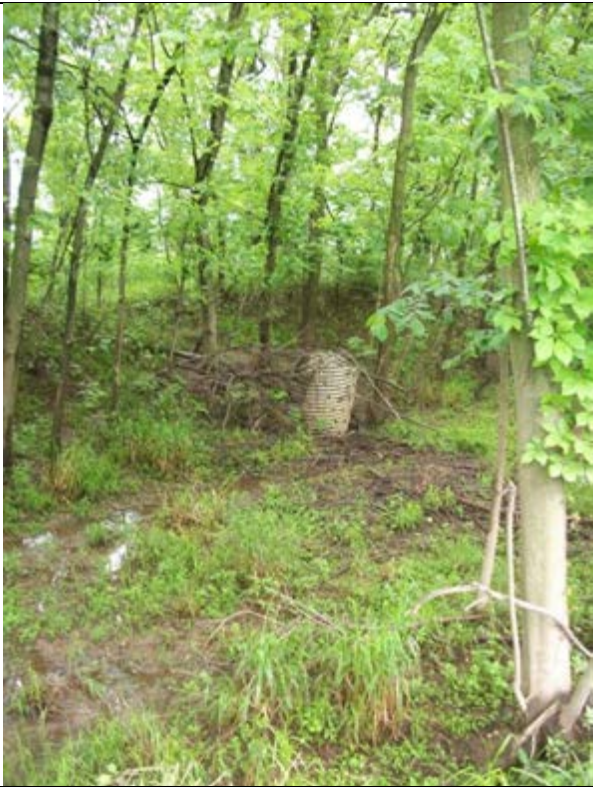
Client Name: U.S. Environmental Protection Agency		Site Location: PPL Brunner Island Station Ash Basin No. 6, York Haven, PA		Project No. 170142.30
Photo No. 15	Date: 5/18/2011

A corrugated metal pipe was observed approximately 100 feet south of the access stairs on the outside east embankment slope (Photo 15). This appears to be a remnant discharge structure for a sedimentation basin used during the construction of the Ash Basin No. 6. Reportedly another exists at the West Embankment, however this was not observed by GZA during this inspection.

Direction Photo Taken: Southeasterly				
Description: Perforated CMP near in the area between the toe and the Susquehanna River at approximately the mid-point of the east side embankment. According to review of the design drawings, the pipe appears to be remnants of a temporary sedimentation pond associated with Ash Basin No's 6 original (circa 1978) construction.				
Photo No. 16	Date: 5/18/2011

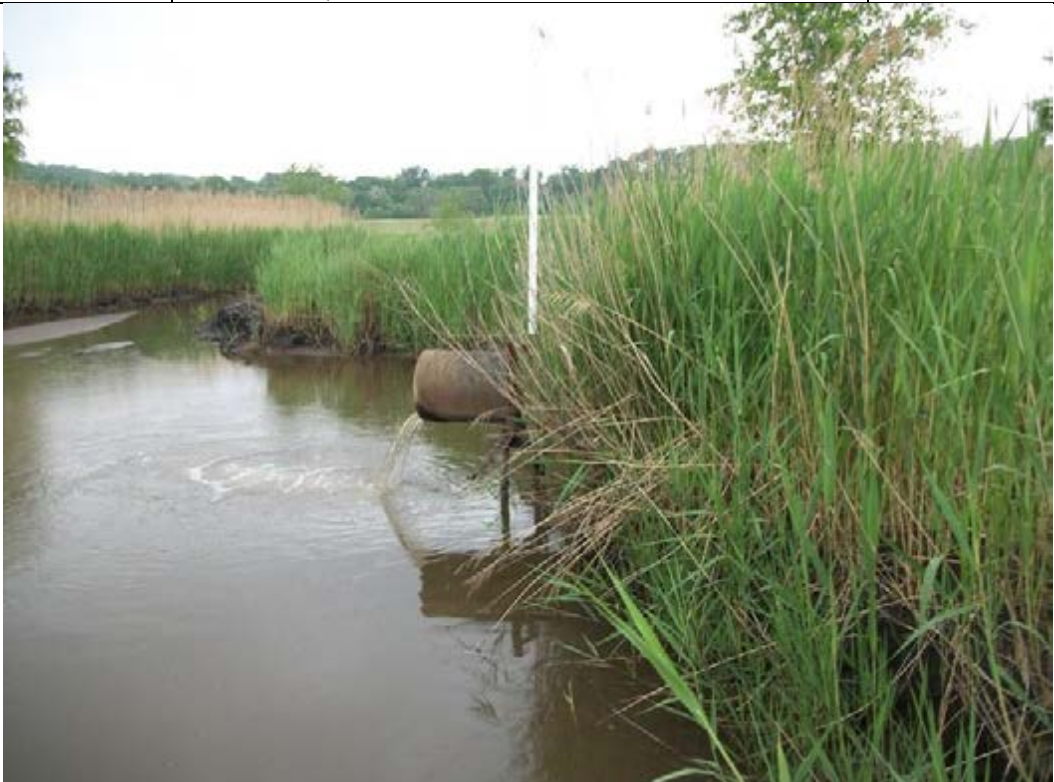
Client Name: U.S. Environmental Protection Agency		Site Location: PPL Brunner Island Station Ash Basin No. 6, York Haven, PA	Project No. 170142.30
Photo No. 17	Date: 5/18/2011

Discharge pipes enter northeast and northwest corners of the Ash Basin No. 6. Waste water flow from the northeast discharge pipe is due to plant waste water flow pumped from the equalization pond and was flowing at the time of inspection (Photo 17). Water flows south in a discharge channel approximately 12 to 20 feet in width, through the filled in north sub-basin and joins with flow from the northwest corner prior to flowing into the central sub-basin. Discharge from the northwest corner is from residual waste water from the concrete bottom ash sluice trough/pond. At the time of the inspection discharge water appeared to contain CCWs (Photo 19). These

Direction Photo Taken: Westerly			
Description: Decanted effluent discharge outfall from the Equalization Pond. Outfall situated at the north end of the basin.			
Photo No. 18	Date: 5/18/2011

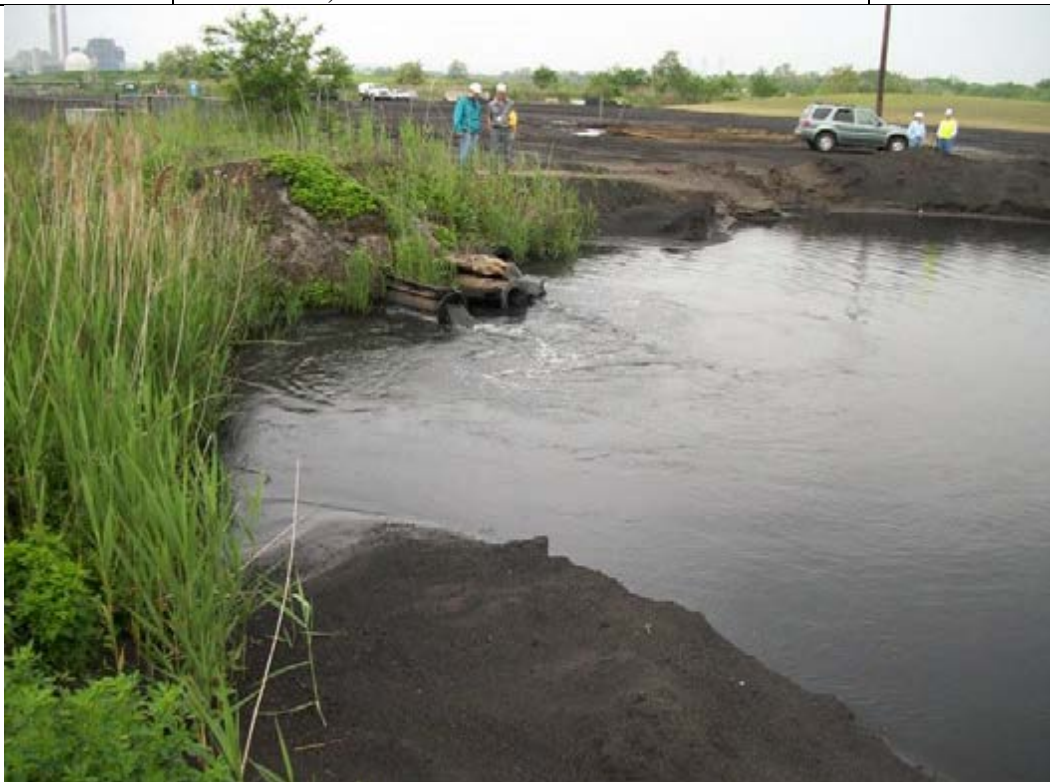
Client Name: U.S. Environmental Protection Agency		Site Location: PPL Brunner Island Station Ash Basin No. 6, York Haven, PA	Project No. 170142.30
Photo No. 19	Date: 5/18/2011

Direction Photo Taken: Northeasterly			
Description: Outflow from Boiler Unit Nos. 1 and 2 Bottom Ash Slurry Treatment System discharging into the northeast end of (the partially closed/inactive portion) of Ash Basin No. 6.

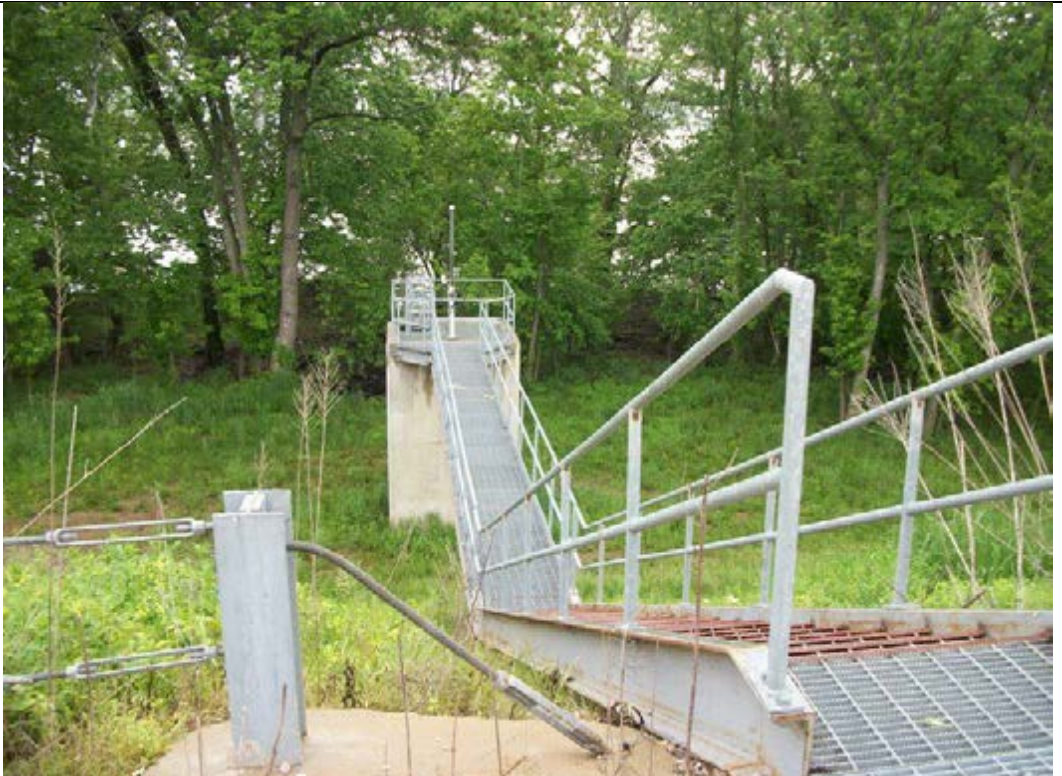
Photo No. 28	Date: 5/18/2011

The outlet structure from the Polishing Pond consists of two 60-inch drop inlets feeding into a 48 inch RCP (Photos 24 & 25). The 48-inch pipe leads to a new gate vault just downstream of the toe of slope and upstream of the discharge point to the Susquehanna River (Photos 28 & 32). The Vault was designed by Kleinschmidt in 2007. Water then discharges through a headway and 48-inch flap gate to an approximately 10 foot wide discharge channel to the Susquehanna River (Photos 33 & 34). The drop inlets and gate vault appeared to be in satisfactory condition at the time of the inspection. Some surface erosion was observed at the discharge headwall.

Direction Photo Taken: Southeasterly		
Description: Gate structure for 48-inch discharge pipe from Polishing Pond overflow structure as viewed from crest of east embankment.

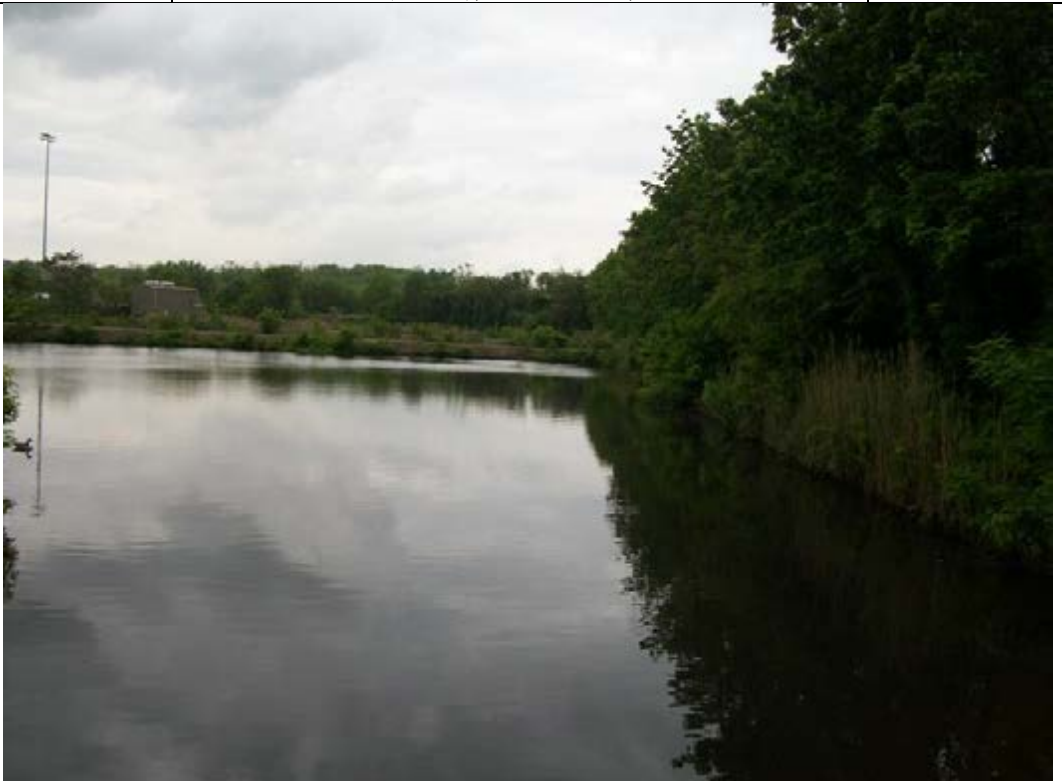
Client Name: U.S. Environmental Protection Agency		Site Location: PPL Brunner Island Station Incidental Waste Treatment Basin (IWTB), York Haven, PA	Project No. 170142.30
Photo No. 45	Date: 5/18/2011

Direction Photo Taken: Northwesterly			
Description: Overview of the south lagoon from the Decant Gate and Sensor Equipment Monitoring Structure. Note north side of north lagoon as well as the east sides of the north, middle and south lagoons are bordered by the Susquehanna Flood Control Levee, the top of which is approximately 11 feet higher than the incised IWTB lagoons.

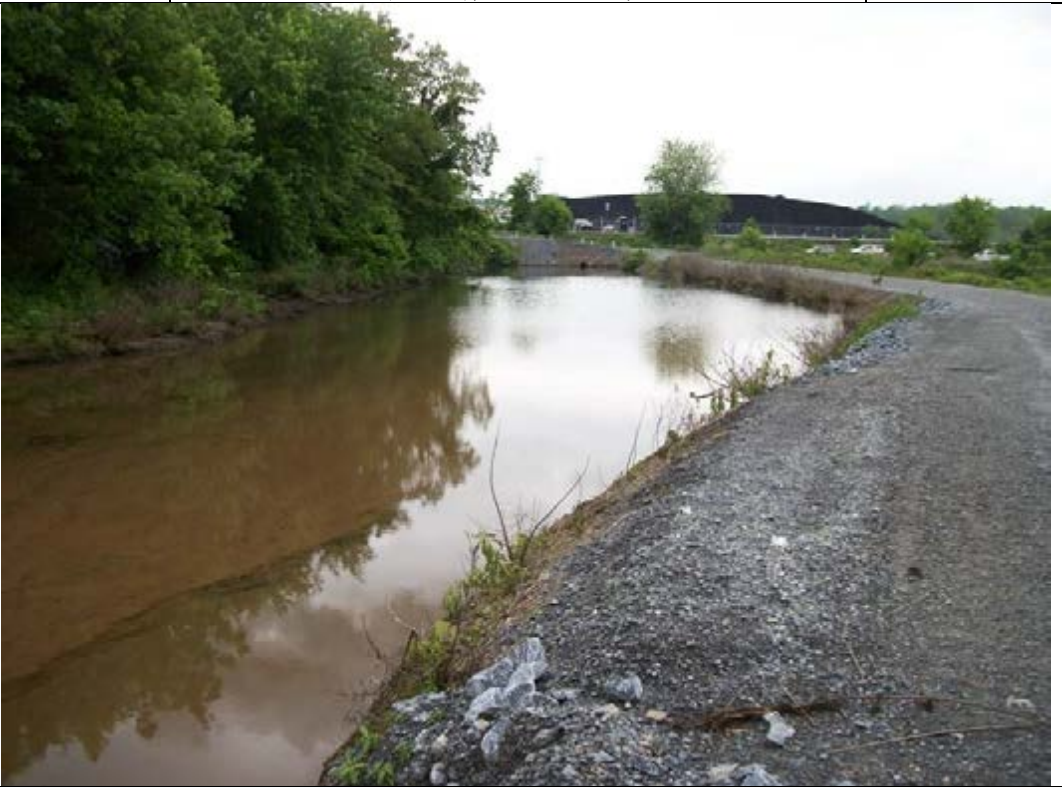
Client Name: U.S. Environmental Protection Agency		Site Location: PPL Brunner Island Station Incidental Waste Treatment Basin (IWTB), York Haven, PA	Project No. 170142.30
Photo No. 47	Date: 5/18/2011

Direction Photo Taken: Southwesterly			
Description: Intake Water Treatment Plant solids settling basin situated at the southern most portion of the IWTB. Note water flows to the canal which runs along the west side of the IWTB to the Coal Pile Runoff Treatment Facility.			
Photo No. 48	Date: 5/18/2011

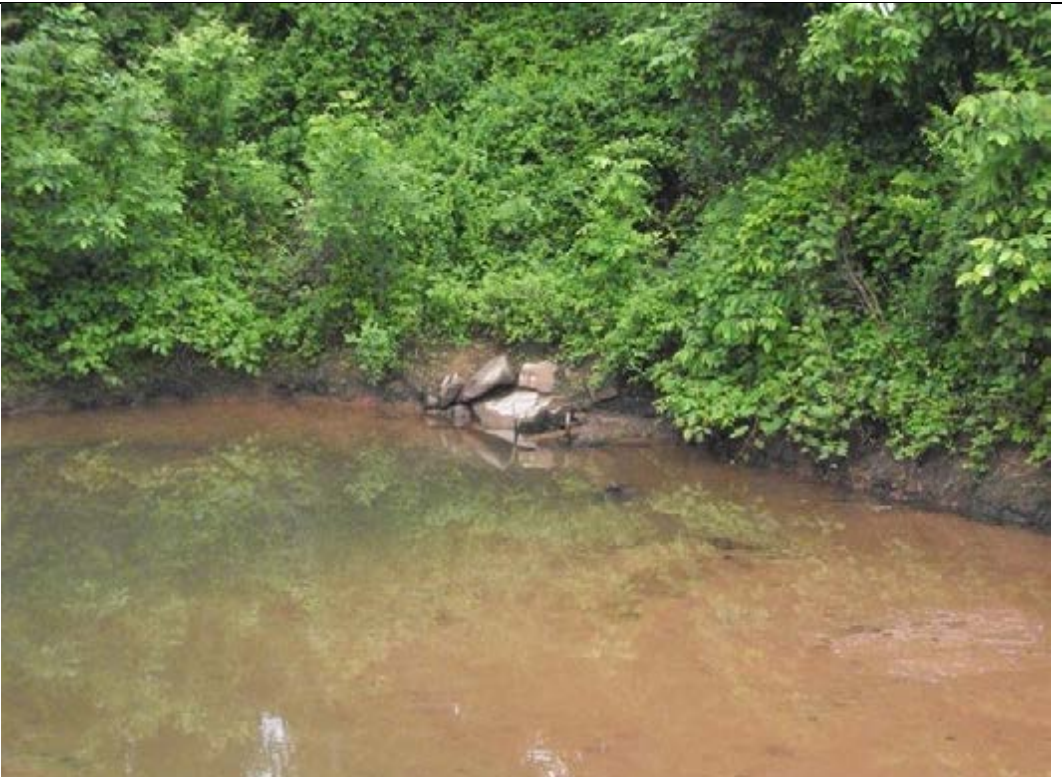
Direction Photo Taken: Southerly			
Description: Stone protection over CMP discharge pipe at eastern end of Intake Water Treatment Plant solids settling basin. Flow through pipe is discharge from the Intake Water Treatment Plant which is located approximately 650 feet southeast of this location.

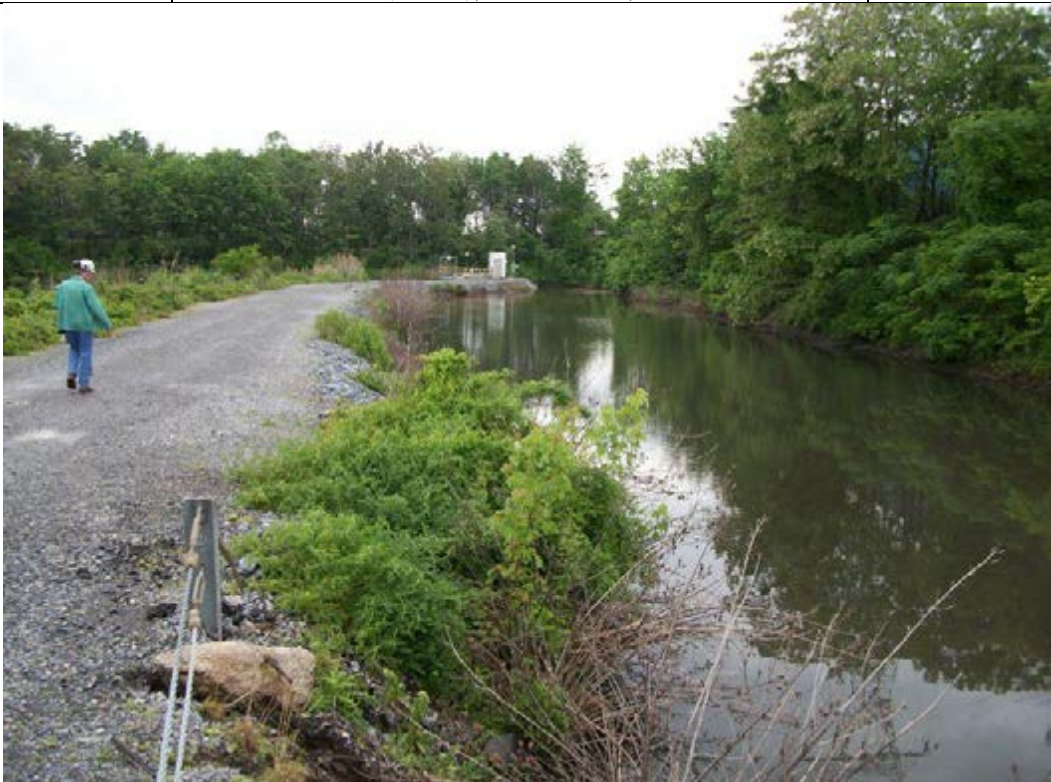
Client Name: U.S. Environmental Protection Agency		Site Location: PPL Brunner Island Station Incidental Waste Treatment Basin (IWTB), York Haven, PA	Project No. 170142.30
Photo No. 49	Date: 5/18/2011

Direction Photo Taken: Easterly			
Description: Intake Water Treatment Plant solids settling basin viewed from the west end. Note common dike separating the basin and south lagoon (left).

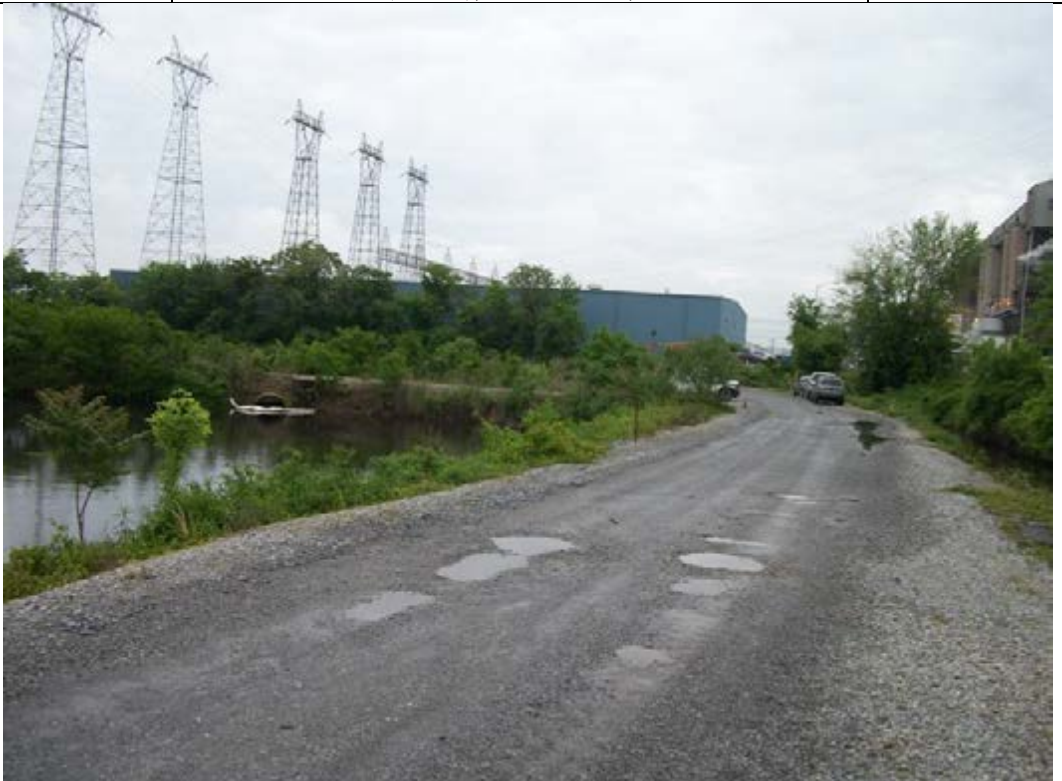
Client Name: U.S. Environmental Protection Agency		Site Location: PPL Brunner Island Station Incidental Waste Treatment Basin (IWTB), York Haven, PA	Project No. 170142.30
Photo No. 53	Date: 5/18/2011

Direction Photo Taken: Southeasterly			
Description: Travel way dike along western side of IWTB. Canal along right side of travel way conveys water to the Coal Pile Runoff Treatment Facility for eventual discharge into the north lagoon.

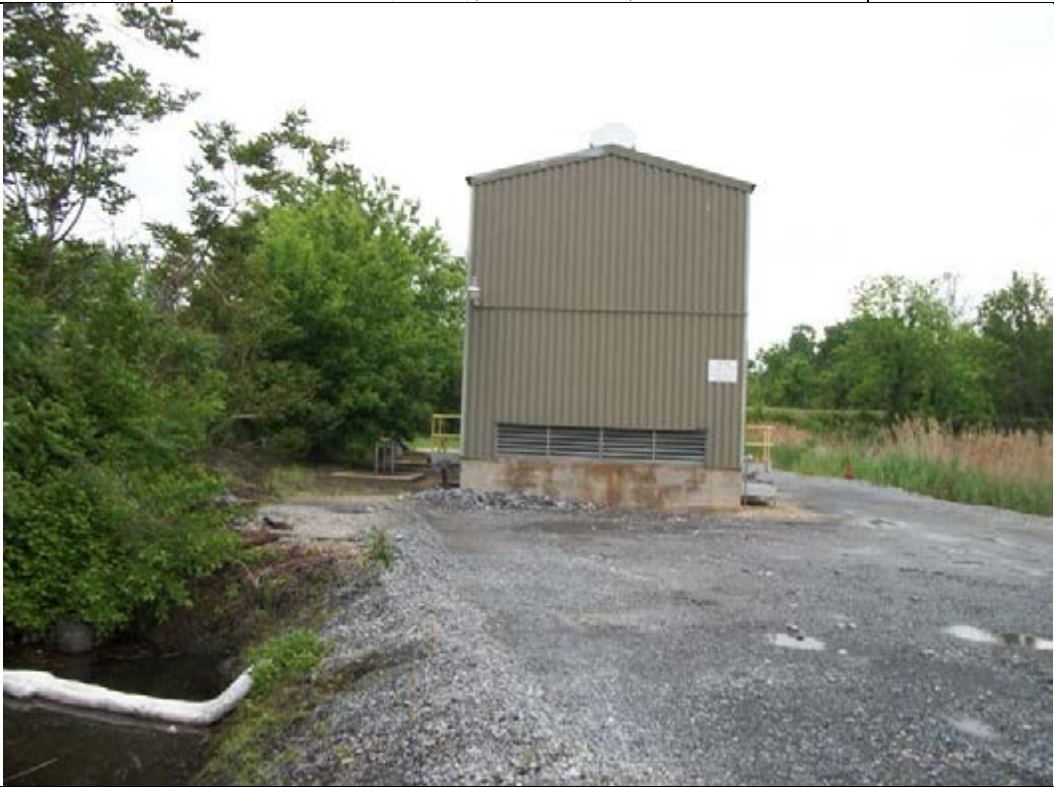
Client Name: U.S. Environmental Protection Agency		Site Location: PPL Brunner Island Station Incidental Waste Treatment Basin (IWTB), York Haven, PA	Project No. 170142.30
Photo No. 59	Date: 5/18/2011

Direction Photo Taken: Northwesterly			
Description: View of Coal Pile Runoff Water Treatment Facility at northwestern portion of the IWTB. Note concrete intake from west side canal (lower left).			
Photo No. 60	Date: 5/18/2011

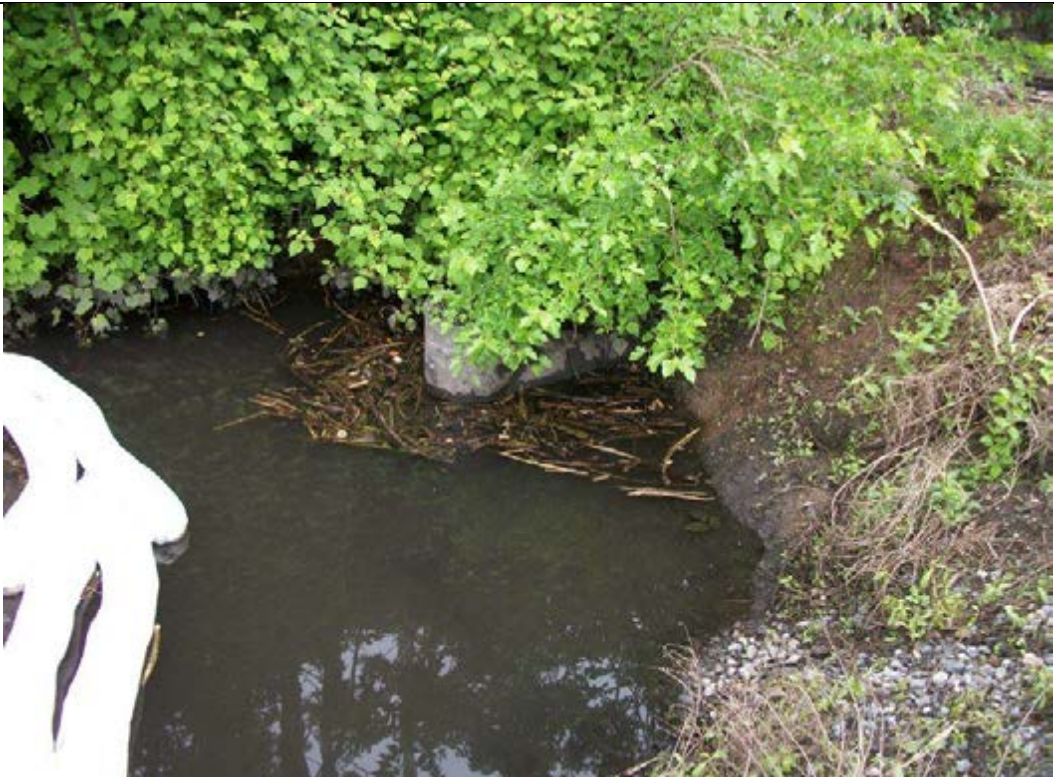
Direction Photo Taken: Westerly			
Description: Intake, from west side canal, to the Coal Pile Runoff Water Treatment Facility.

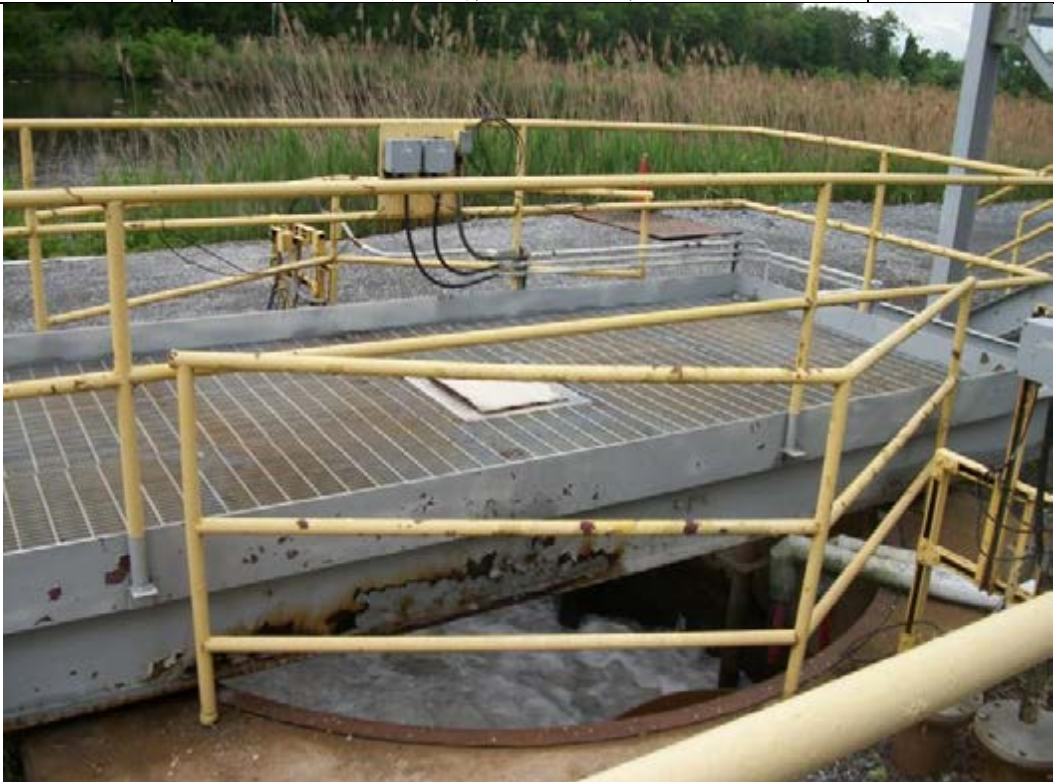
Client Name: U.S. Environmental Protection Agency		Site Location: PPL Brunner Island Station Incidental Waste Treatment Basin (IWTB), York Haven, PA	Project No. 170142.30
Photo No. 61	Date: 5/18/2011

Direction Photo Taken: Easterly			
Description: Mixing tanks at Coal Pile Runoff Treatment Facility. Note water is discharged from the treatment facility to the north lagoon.			
Photo No. 62	Date: 5/18/2011

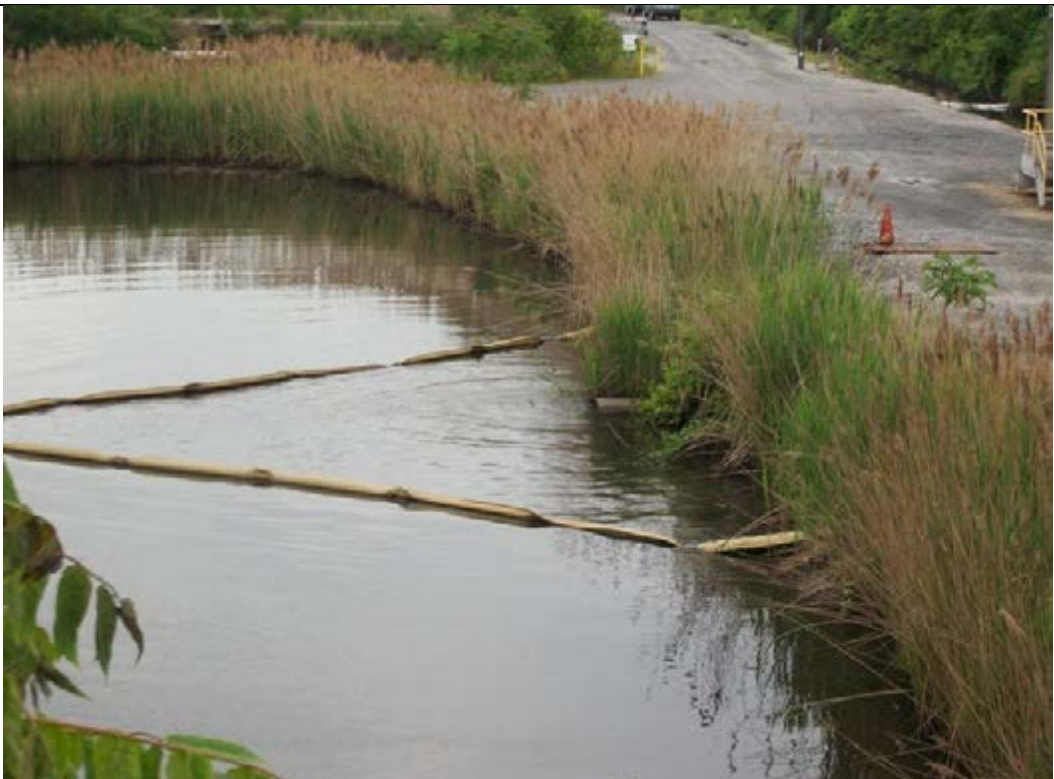
Direction Photo Taken: Southerly			
Description: Discharge outfall from Coal Pile Runoff Treatment Facility into the north lagoon. Discharge pipe is fully surrounded by turbidity curtains. Note high vegetation on inside slopes.

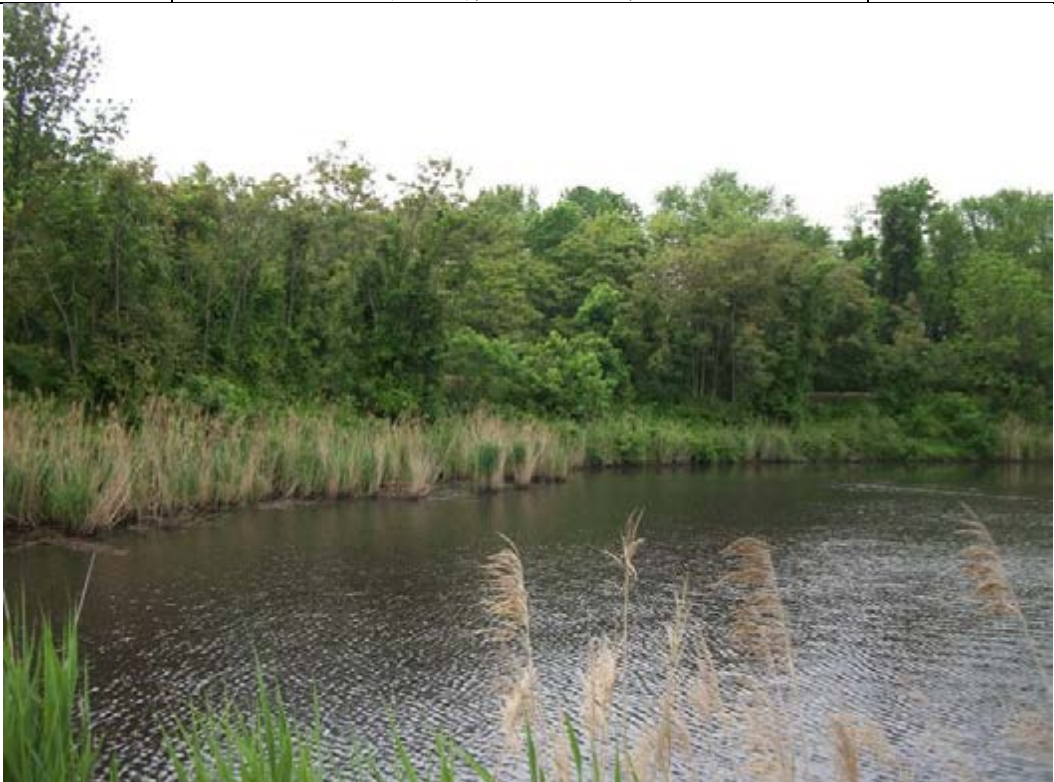
Client Name: U.S. Environmental Protection Agency		Site Location: PPL Brunner Island Station Incidental Waste Treatment Basin (IWTB), York Haven, PA	Project No. 170142.30
Photo No. 63	Date: 5/18/2011

Direction Photo Taken: Northeasterly			
Description: North lagoon as viewed from the southwest. North lagoon is bounded on the north and east sides by the Susquehanna Flood Control Levee (mostly hidden just beyond the trees).			
Photo No. 64	Date: 5/18/2011

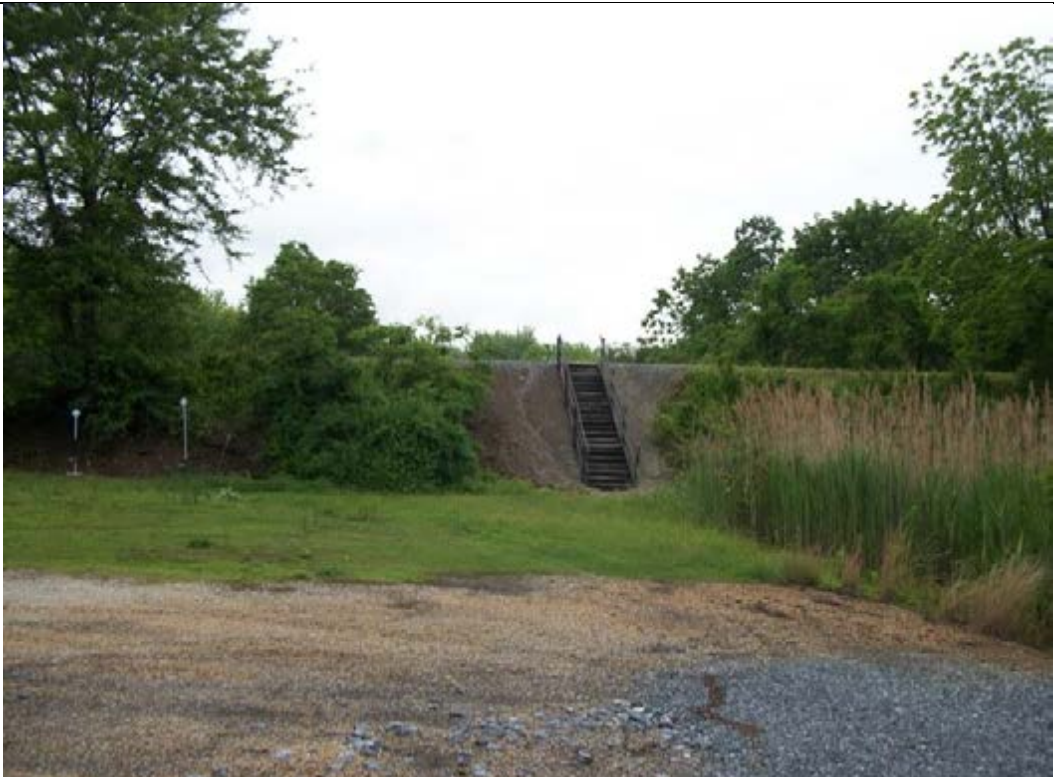
Direction Photo Taken: Northerly			
Description: View of Susquehanna Flood Control Levee which makes up the north embankment of the north IWTB lagoon (as well as the east side of the north, middle and south lagoons).
